**Inspection and Examination
Report of Duke Energy
Carolinas, LLC and Duke
Energy Progress, LLC**
*December 2022 Winter Storm
Outages and Blackouts*

Docket No. ND-2023-1-E

August 25, 2023

Prepared for the South Carolina
Office of Regulatory Staff by

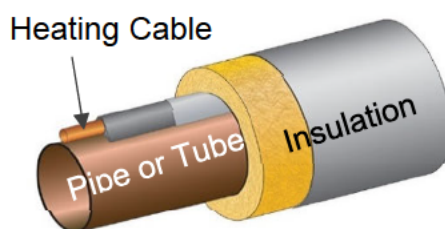
Freeze protection measures commonly used by power plants on piping and instrumentation lines that are exposed to the elements.

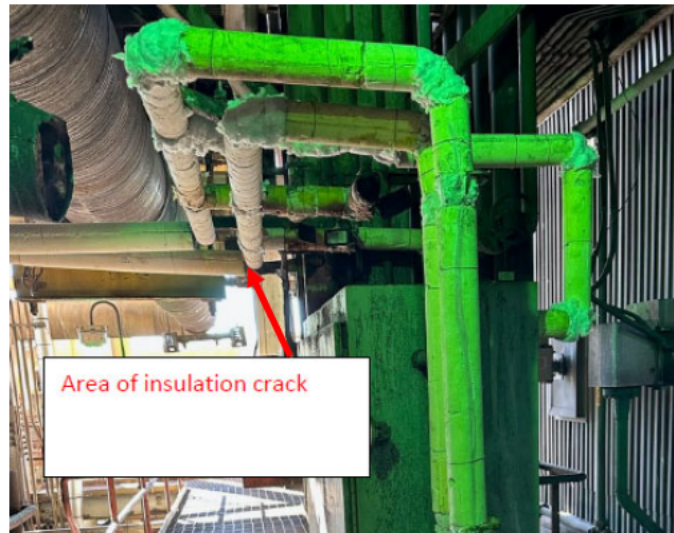
Figure 3-11: Cracked Insulation on Sensing Lines Discovered at Roxboro Unit 3^{liv}

troubleshooting efforts to return the pump to service began immediately, Duke Energy staff was unable to resolve the issue on December 24.^{lii} Troubleshooting resumed on the morning of December 25, and a crack was discovered in the insulation of one of the sensing lines that allowed ingress of cold air. After the sensing lines were thawed and the pump was repaired, the Roxboro unit was brought back on-line that evening.^{liii} Figure 3-11 below is a picture provided by DEP identifying the location of the cracked insulation.

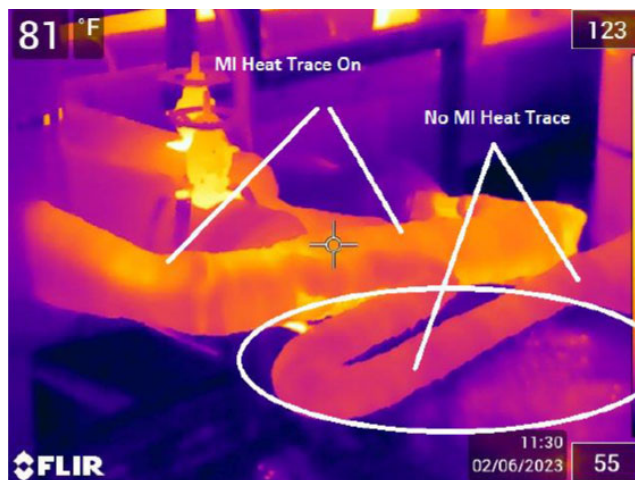
Figure 3-12: Lack of Heat Tracing Discovered at Dan River Unit 9^{lvi}

DEC's Dan River Unit 9 tripped off-line just before midnight on December 23 due to frozen instrumentation, resulting in a loss of 359 MW of generating capacity. Dan River Unit 9 was not returned to service until after midnight on December 25. When Duke Energy performed a causal analysis^{lv} after the Load Shed Event, it was determined that freezing of the instrumentation lines occurred due to improper application and installation of heat trace tape. As part of the causal analysis investigation, testing was performed on the identically designed Unit 8, which showed that the instrumentation self-regulating heat trace cabling was not contributing to the current (amperage) load on the circuit. The causal analysis concluded that the self-regulating heat trace was not working as designed likely because it was rated for a maximum intermittent process temperature well below what it regularly experienced during operation. In addition, Duke Energy had not updated the drawings to reflect all the installed weatherization measures, specifically the heat tracing, and poor configuration management contributed to the outage. The causal analysis also noted less than adequate quality control and engineering from initial construction of the plant. Figure 3-12 below shows piping where heat trace tape was found not applied.

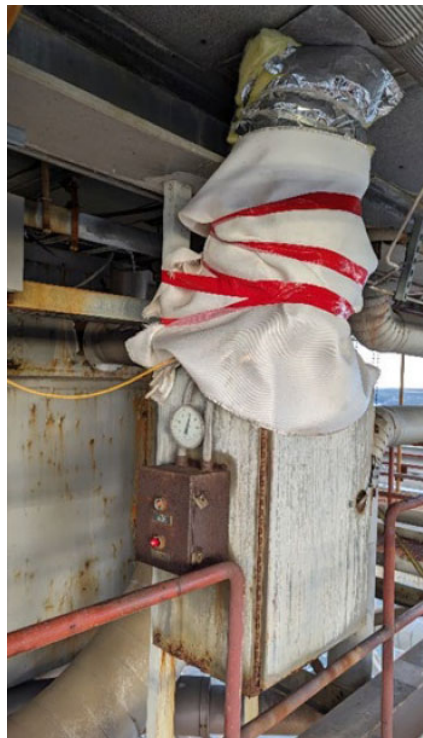
Figure 3-13: Temporary Mayo Unit 1 Weatherization^{lvii}

Frozen sensing lines and frozen limestone resulted in a 336-350 MW derate of DEP's Mayo Unit 1 from 713 MW by from December 24 through December 25. DEP's inspection identified the insulation and heat tracing were intact and operational; however, one section of the instrument line was outside and exposed to cold and wind, which overcame the freeze protection measures in place. The affected section of the line was covered with temporary additional insulation after the issue was discovered.
