**Inspection and Examination
Report of Duke Energy
Carolinas, LLC and Duke
Energy Progress, LLC**
*December 2022 Winter Storm
Outages and Blackouts*

Docket No. ND-2023-1-E

August 25, 2023

Prepared for the South Carolina
Office of Regulatory Staff by

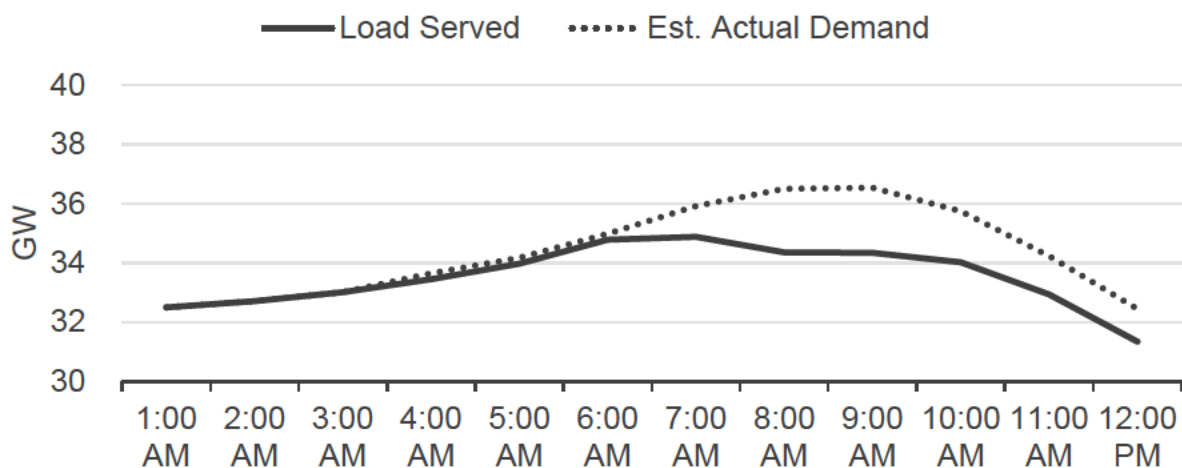
Figure 2-1: Duke Energy Hourly Demand, Morning of December 24^{xvii, 1718}

As the morning progressed, the actual load on the combined Duke Energy system outpaced the day’s forecast. Figure 2-1 below illustrates Duke Energy’s escalating load on the morning of December 24. The figure depicts both the load Duke Energy actually served and estimated actual demand. The estimated actual demand includes additions to the actual load served for DSM and load shed reductions. The hourly integrated peak load Duke Energy served was 34,884 MW from 6:00 to 7:00 AM, and the estimated actual demand (considering estimated additions for DSM and load shed reductions) was 36,543 MW from 8:00 to 9:00 AM.

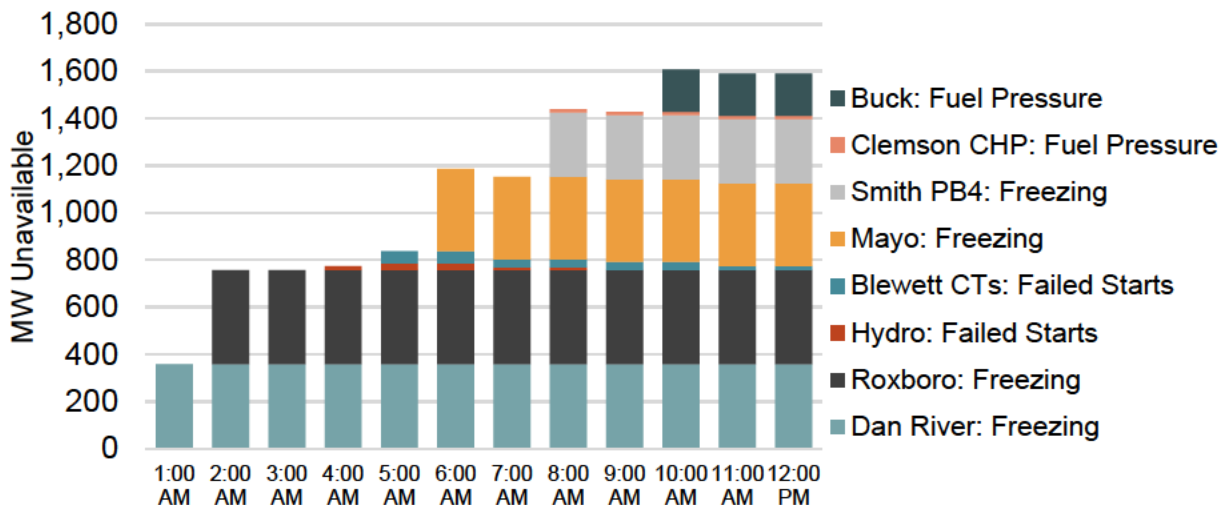
Figure 2-2: Duke Energy Generation Plant Outages, Morning of December 24^{xviii}

As actual load on the Companies' system increased and outpaced forecasted load, several of Duke Energy's generation resources began to fail. The generation outages and derates that occurred on the Companies' system are discussed in further detail in Section 3.2. There were several generating resources unavailable due to planned maintenance outages, and several others were already in forced outage status for various reasons leading up to the Load Shed Event. Prior to December 24, 3,895 MW of generation was off-line. In the early hours of December 24, depicted by Figure 2-2 below, several plants experienced operational issues associated with the extreme weather conditions and had to be shut down or derated. The operational issues further reduced Duke Energy's available capacity to serve load.

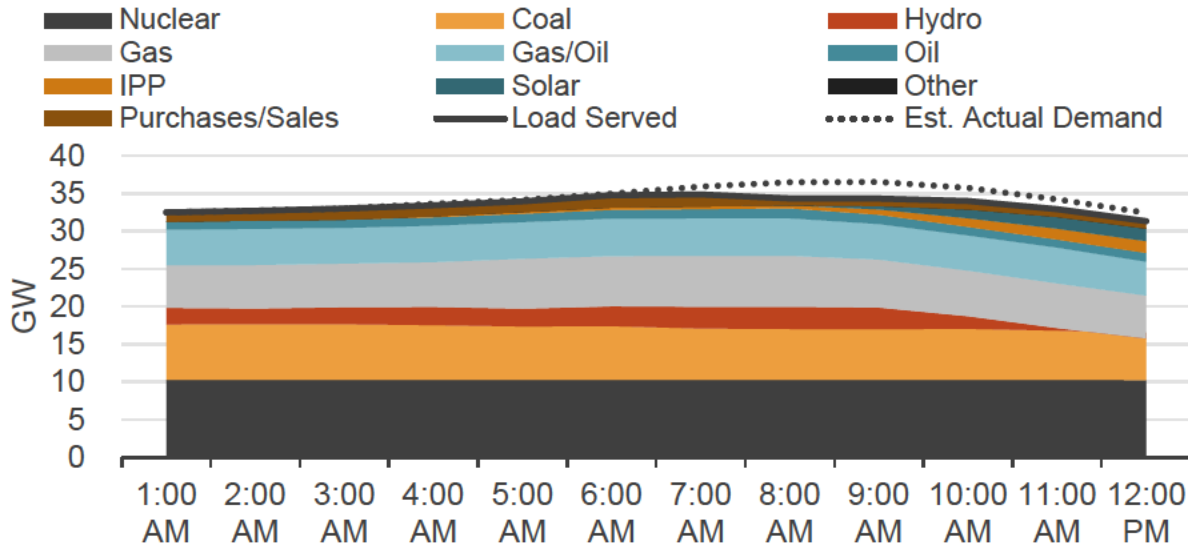
Figure 2-3: Duke Energy Hourly Demand and Supply, Morning of December 24^{xx,20}

In addition to its owned generation resources, Duke Energy also encountered supply unavailability from third-party sources. Beginning at 5:30 AM, Duke Energy started experiencing curtailments (reductions) to the amount of off-system power purchases it had contracted for on December 23. The entirety of Duke Energy’s non-firm purchases was curtailed, and an increasing amount of firm purchases were also curtailed as the morning of December 24 progressed.^{xix} Generation resources owned by IPPs located in Duke Energy’s Balancing Authority Area (“BAA”) also failed to operate during critical hours of the morning.¹⁹

Figure 2-3 below depicts Duke Energy’s actual estimated hourly demand and supply for the morning of December 24. The generation resource failures are reflected as reduced generation output in the respective fuel categories (gas and coal) at the time the failures occurred. Additionally, curtailed power purchases are reflected in reduced purchases/sales. Duke Energy has several generation plants that are capable of dual fuel operation on either natural gas or oil, and Duke Energy switched several facilities to oil during the Load Shed Event as reflected in the aggregate gas/oil category. Duke Energy exhausted available supply in an attempt to meet demand during the Load Shed Event, meaning all available dispatchable generation was utilized. A meaningful amount of solar was generated from 8:00 to 9:00 AM, which, along with declining load due to increasing temperatures, improved Duke Energy’s supply and demand balance.

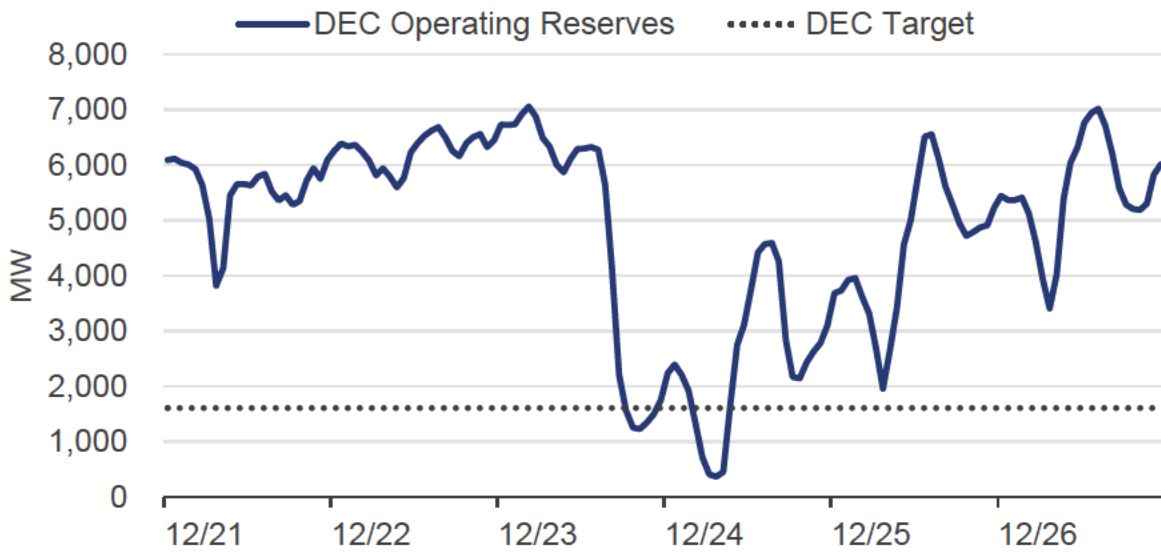
Figure 2-4: DEC Operating Reserves^{xxi}

The imbalance of load and supply manifested in a degradation to the operating reserve levels for the DEC and DEP BAAs. DEC and DEP target minimum levels of operating reserves to comply with NERC standards. These operating reserves provide for regulation, load forecasting error, forced and scheduled resource outages, and local area protection. Figure 2-4 and Figure 2-5 below depict actual levels of operating reserves for the DEP and DEC BAAs respectively versus their relevant reserve targets. Both DEP and DEC carried amounts of reserves exceeding reserve targets until the evening of December 23 when the level of operating reserves rapidly eroded to below targeted levels.

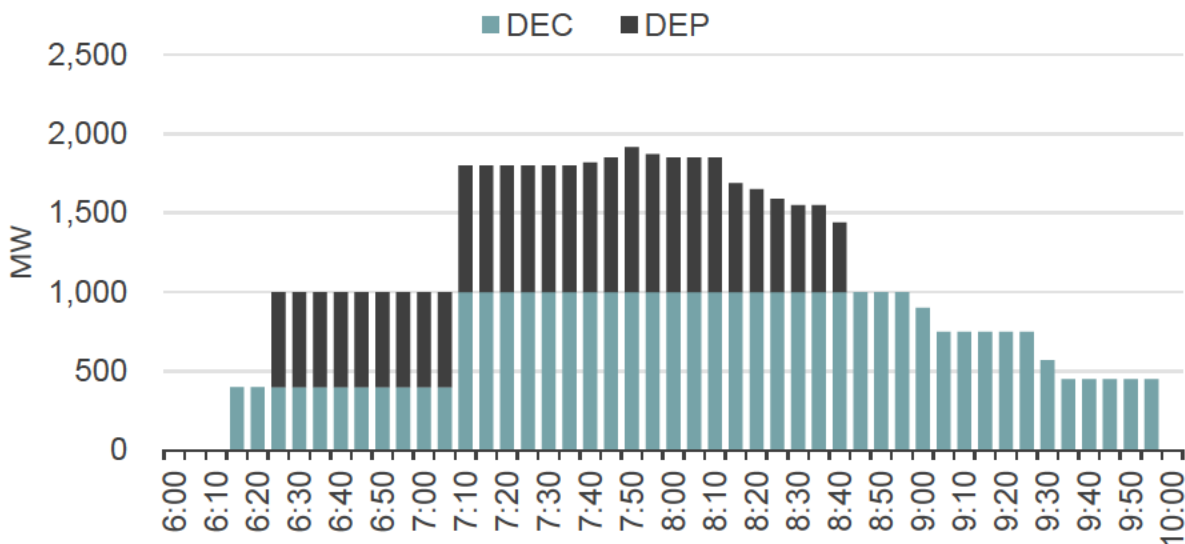
Figure 2-6: DEC and DEP Load Shed Directive^{xxvi,23}

As shown below in Table 2-2 and Figure 2-6, Duke Energy directed increasing amounts of load shed from 6:00 to 8:00 AM and subsequently reduced those directives until they ended at 10:00 AM. At the height of the Load Shed Event, Duke Energy actually implemented an estimated load shed of 1,865 MW from 8:00 to 9:00 AM.^{xxiv}

Duke Energy first experienced failures in its automated RLS tool at 6:57 AM (initially on the DEP system), shortly after implementation of rotating load shed. The Companies shifted to manual load shed procedures at 7:12 AM.^{xxvii} The automated RLS tool used by the Companies was designed to rotate customer outages on a 15- to 30-minute basis. Although DEP ended its load shed request by 8:43 AM and DEC by 10:00 AM, the manual

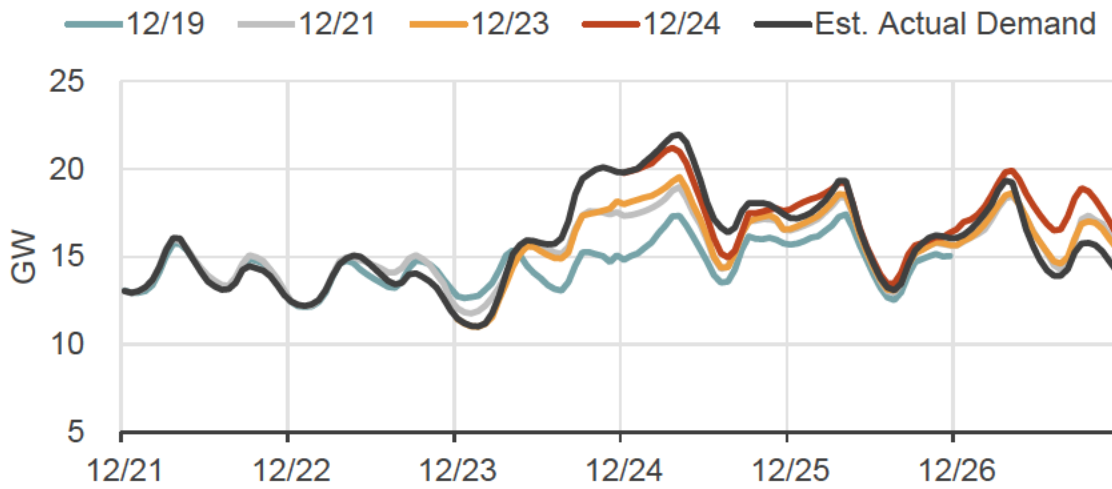
Figure 3-2: DEC Hourly Load Forecasts^{xxx,27}

Figure 3-2 below depicts the DEC load forecast and actual load experienced on the system as of the mornings of Monday, December 19, Wednesday, December 21, Friday, December 23, and Saturday, December 24. Figure 3-3 below shows the same information for DEP. For both Companies, the December 19 forecast did not anticipate elevated loads, but the December 21 forecast reflected increased load levels beginning on the evening of December 23. Each subsequent forecast by the Companies increased anticipated load levels.

As shown below in Table 3-1, DEC’s December 23 forecast missed actual load levels that same evening by more than two (2) gigawatts (“GW”). Throughout December 23, Duke Energy issued four (4) peak load forecasts for the next seven (7) days and three (3) grid status reports.^{xxxii} Despite the large deviation of actual load experienced from forecasted load on December 23, DEC’s peak load forecast for the following day, December 24, did not change from the previous morning’s forecast of 19,548 MW. The December 23 forecast fell below actual peak load of 21,768 MW by 11.4%.²⁸

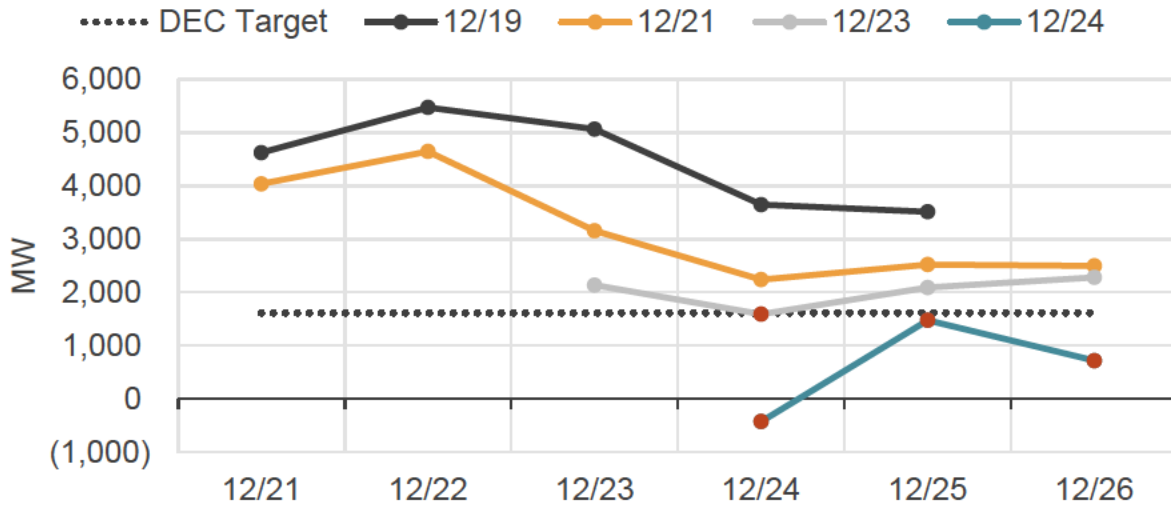
Figure 3-5: DEC Forecasted Operating Reserves^{xxxvi,31}

A component of short-term supply planning included projections of operating reserve levels based on hourly peak load, available dispatchable capacity, forecasted solar at the peak load hour, available load reduction program capacity, and scheduled power purchases and sales. Figure 3-5 and Figure 3-6 below show the projected operating reserve levels for DEC and DEP, respectively, as of the mornings of December 19, December 21, December 23, and December 24.

On December 24, the operating reserve levels were below zero for that day and forecasted to be close to or beneath the target levels for December 25 and 26.

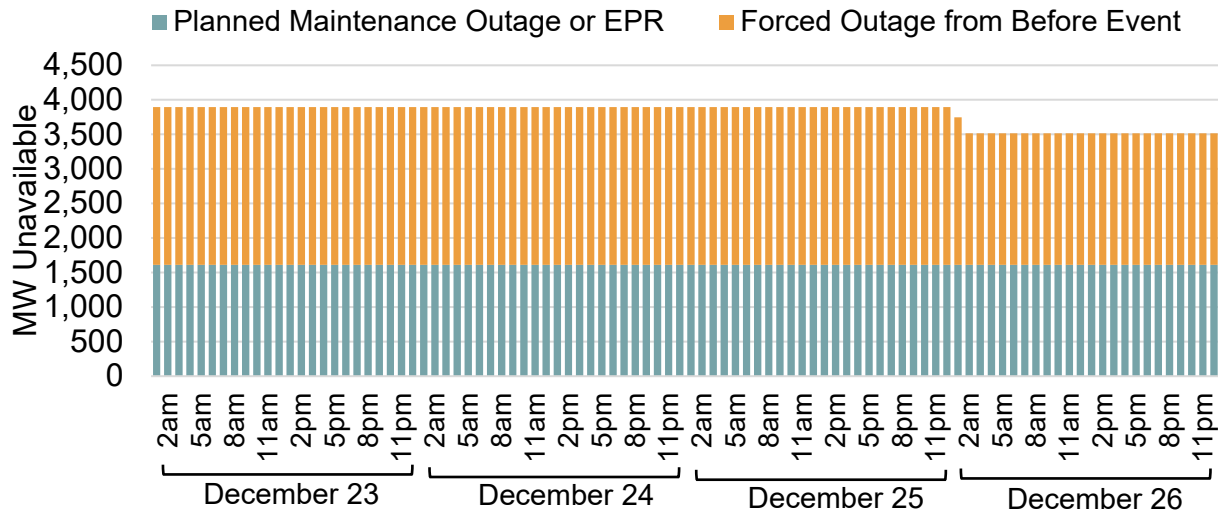
Figure 3-7: Pre-Load Shed Event Generation Plant Outages^{33, xxxviii}

Figure 3-7, Figure 3-8, Figure 3-9, and Figure 3-10 below show the hourly capacity impact of generation outages on the DEC and DEP systems from December 23 through December 26. Figure 3-7 shows the outages that were already underway prior to the arrival of Winter Storm Elliott. These outages are further discussed in Section 3.2.1 below.

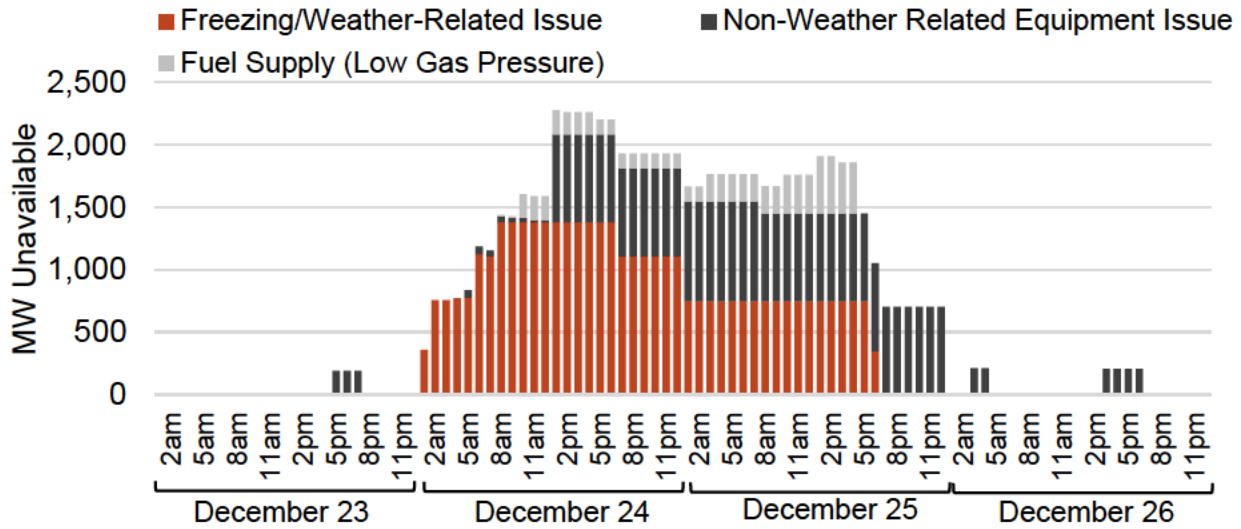
Figure 3-8: Unplanned Generation Plant Outages During Event by Cause/Reason^{xxxix}

Figures 3-8 and 3-9 below depict the unplanned outages and derates that occurred in the hours immediately prior to and during the Load Shed Event. The unplanned outages were in addition to the outages that started prior to Winter Storm Elliott. These unplanned outages are further discussed in Section 3.2.2.

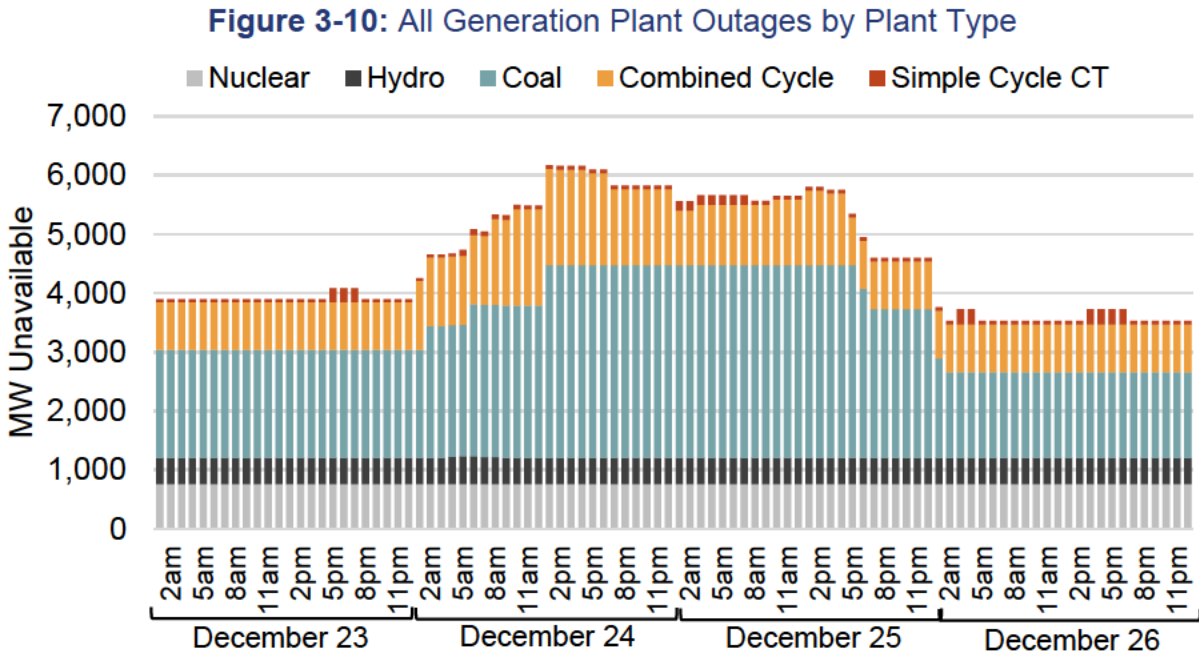
Figure 3-10 below shows all of the generation plant outages from December 23 to December 26 combined. A more detailed list of all of the generation plant outages is provided in Appendix C.^{xliii}

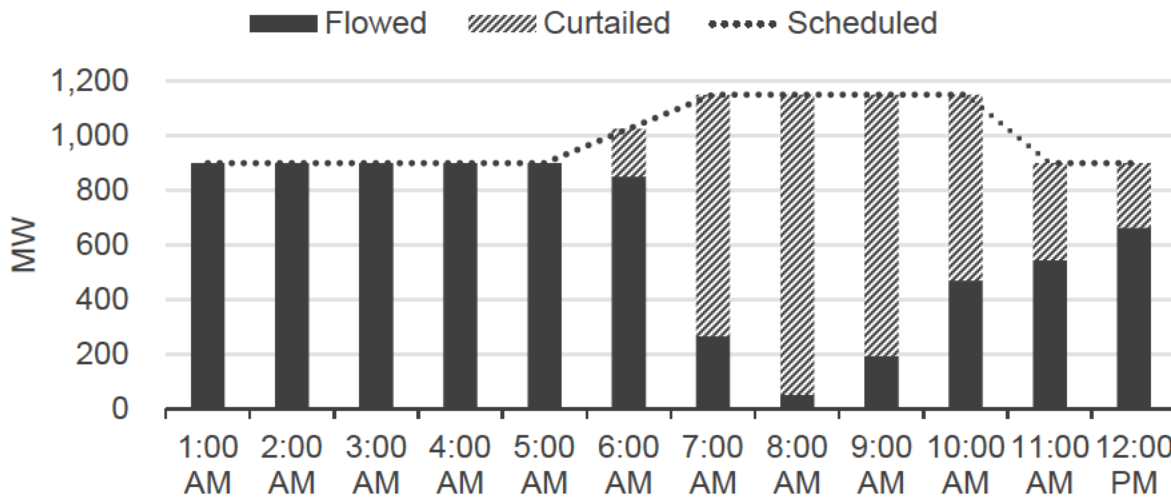
Figure 3-14: Curtailed PJM Purchases, Morning of December 24^{lxii,37}

On the evening of December 23, Duke Energy’s non-firm purchases from PJM were curtailed for several hours. On December 24, Duke Energy’s firm and non-firm purchases from PJM were curtailed starting at 5:30 AM. As shown below in Figure 3-14, the amount of curtailments increased to nearly 100% during the hour of 7:00 to 8:00 AM, which coincided with peak demand on the Duke Energy system during the Load Shed Event. After 8:00 AM, the level of curtailment began to decrease until eventually all curtailment by PJM of firm and non-firm purchases ended after noon on December 24.

Based on its wide area impact, Winter Storm Elliott also heavily impacted supply and demand in the PJM footprint driving the RTO to initiate its own emergency procedures in accordance with its FERC approved Tariff and NERC Reliability Standards.^{lxiii} After 4:00 AM, PJM entered EEA 2 and among other actions, terminated scheduled energy exports from PJM.³⁸ The widespread nature of Winter Storm Elliott and its impact on Duke Energy’s neighbor utilities eliminated almost all external support to Duke Energy during the peak load hours on the morning of December 24.

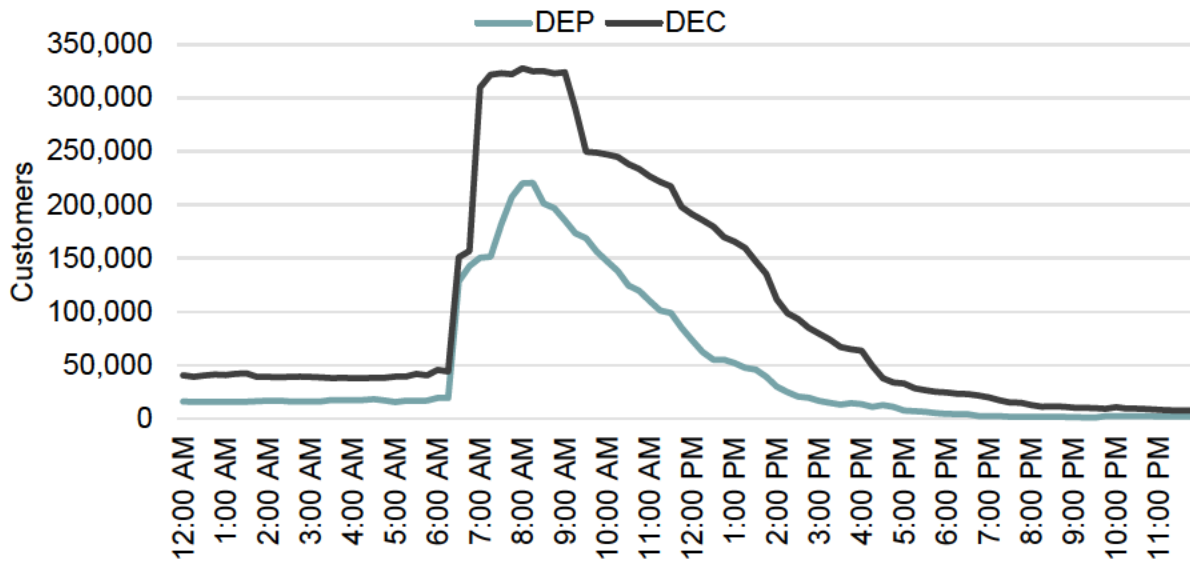
Figure 3-15: North and South Carolina Customers on Outage, December 24^{lxix}

Figure 3-15 below shows the number of customers with an outage on December 24. The figure includes customer outages in both North Carolina and South Carolina for any reason (load shed, wind event, other). DEC experienced its maximum amount of customer outages around 7:00 AM, whereas DEP's peak outages were an hour later at 8:00 AM. For the Companies, the manual restoration process gradually reduced the number of customer outages throughout December 24.

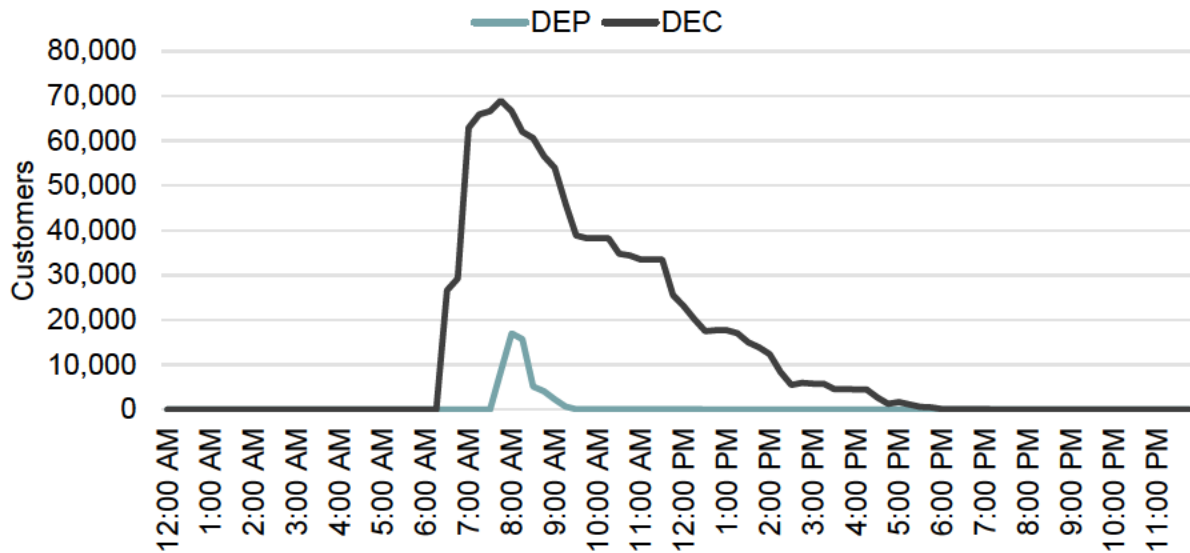
Figure 3-16: South Carolina Load Shed Outages, December 24^{lxxx}

Figure 3-16 below depicts the number of customer outages in South Carolina and is inclusive only of outages caused by load shed. Based on each Company's service territory and the areas prioritized for load shed, a larger number of DEC customers experienced outages versus DEP customers. For DEC, the customer-weighted average outage time was 186 minutes and the maximum outage time was 610 minutes. For DEP, the customer-weighted average outage time was 49 minutes, and the maximum outage time was 414 minutes.

Because of the failure of Duke Energy’s RLS tool, customer outages were extended and restoration was delayed. If the RLS tool had operated successfully, customer outages would have been limited to 15- to 30-minutes and restoration would have been completed more quickly.

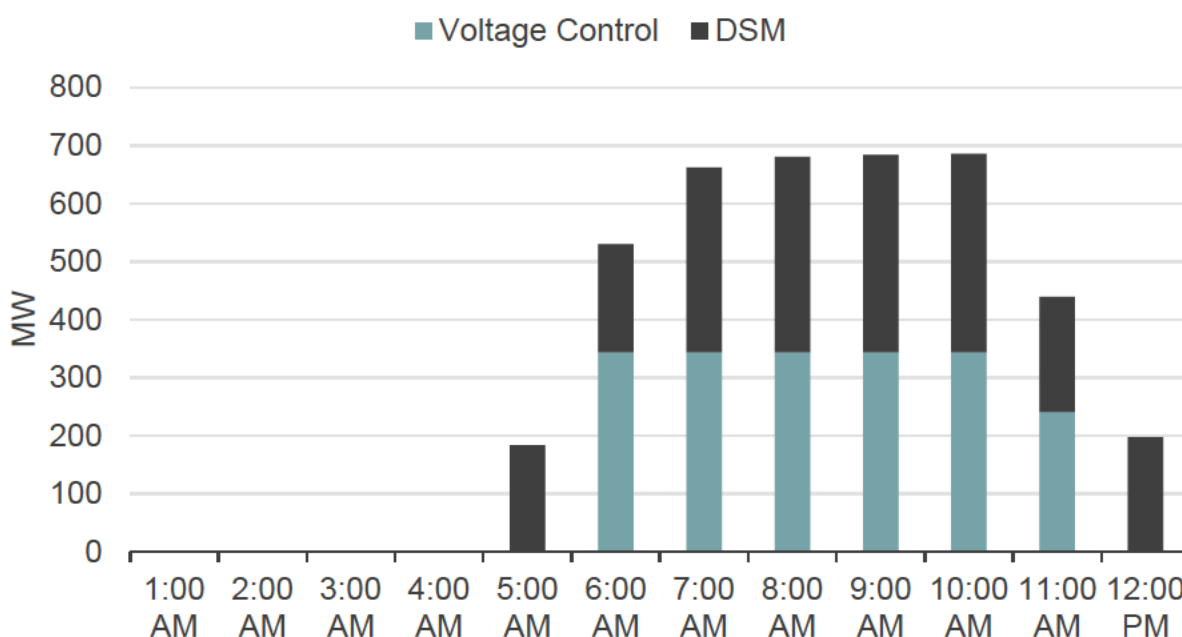
Figure 4-1: Duke Energy Active Load Reduction, Morning of December 24^{xciii}

On December 24, Duke Energy chose not to utilize certain load reduction programs with total capacities of 40 MW. These programs included its residential programs and a small commercial program.^{xcii} On December 23, Duke Energy made a supply planning decision to reserve its residential programs for December 26. The commercial program was not utilized based on its small size and holiday timing.
